**Flood Control Project Maintenance
Levee Inspections**
LMA District Cover Sheet
Spring 2017 Levee Inspection Results

Reclamation District No. 2107 Mossdale Island

Levee Inspection Report By Mile - Spring 2017

Waterway	Bank	Unit Miles	Inspection Start/End	Inspector
Unit No. 01 San Joaquin River	Left	2.33	03/30/2017 03/30/2017	Maksim Khashchuk

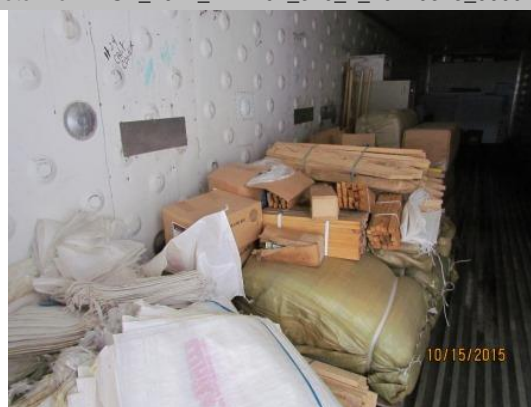
Photo 1 of 1 : SP_2017_RD2107_329_7_20170313_00002.jpg

LM Start		Rating **	A	Issue No.	7
LM End		Issue Type +	Ma	Location *	LS
Category	Earthen Levee		GPS Latitude/Longitude		
			Start	End	
Item	Emergency Supplies & Equipment				
DWR ID	DWR_RD2107_01_s_2013_7				
Comment Code					
Inspector Comment					
Flood fighting supplies are available on-site.

View of the flood fight emergency supplies.

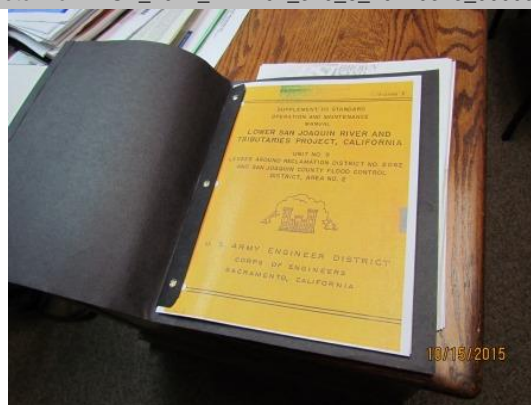
Photo 1 of 1 : SP_2017_RD2107_329_8_20170313_00003.jpg

LM Start		Rating **	A	Issue No.	8
LM End		Issue Type +	Ma	Location *	LS
Category	Earthen Levee		GPS Latitude/Longitude		
			Start	End	
Item	Operations & Maintenance Manuals				
DWR ID	DWR_RD2107_01_s_2013_8				
Comment Code					
Inspector Comment					
The O&M Manual is available at the LMA's office.

View of the O&M Manual.

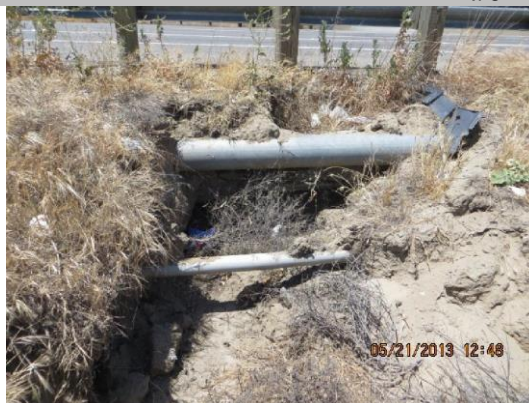
Photo 1 of 1 : UCIP_SP_2017_16187_27294.jpg

LM Start	0.23	Rating **	M	Issue No.	58
LM End	0.23	Issue Type +	En	Location *	WS
Category	Supplemental			GPS Latitude/Longitude	
				Start	End
Item	DWR UCIP Field Study			37.784586 °	37.784586 °
				-121.306837 °	-121.306837 °
DWR ID					
Comment Code					
Inspector Comment					
FS_ID:16187 DS_ID:23107 EP_NO: N/A Repair Type: Non-Urgent Crossing Status: Found UCIP Comments: No permit identified. Erosion exposed pipes on LS. FIELD_STRUCT_DESC: 3-inch PVC conduit 1-foot below the road surface within roadway fill over levee crown. FS Date: 5/22/2013

Pipes visible on LS next to roadway.

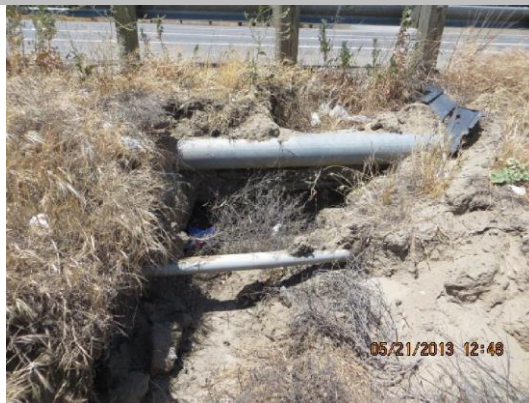
Photo 1 of 2 : UCIP_SP_2017_15173_24918.jpg

LM Start	0.23	Rating **	M	Issue No.	60
LM End	0.23	Issue Type +	En	Location *	WS
Category	Supplemental			GPS Latitude/Longitude	
				Start	End
Item	DWR UCIP Field Study			37.784586 °	37.784586 °
				-121.306837 °	-121.306837 °
DWR ID					
Comment Code					
Inspector Comment					
FS_ID:15173 DS_ID:23109 EP_NO: N/A Repair Type: Non-Urgent Crossing Status: Found UCIP Comments: No permit identified for this crossing. Erosion exposed pipes on LS. FIELD_STRUCT_DESC: 1.5-inch PVC conduit 1-foot below the road surface within roadway fill over levee crown. FS Date: 5/22/2013

Pipes visible on LS next to roadway.

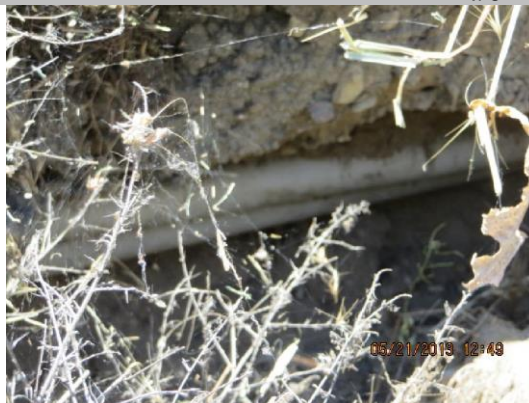
Photo 2 of 2 : UCIP_SP_2017_15173_24917.jpg

LM Start	0.23	Rating **	M	Issue No.	60 (cont)							
LM End	0.23	Issue Type +	En	Location *	WS							
Category	Supplemental		GPS Latitude/Longitude									
			Start	End								
Item	DWR UCIP Field Study		37.784586 °	37.784586 °								
			-121.306837 °	-121.306837 °								
DWR ID												
Comment Code												
Inspector Comment												
FS_ID:15173 DS_ID:23109 EP_NO: N/A Repair Type: Non-Urgent Crossing Status: Found UCIP Comments: No permit identified for this crossing. Erosion exposed pipes on LS. FIELD_STRUCT_DESC: 1.5-inch PVC conduit 1-foot below the road surface within roadway fill over levee crown. FS Date: 5/22/2013

Pipes visible on LS next to roadway.

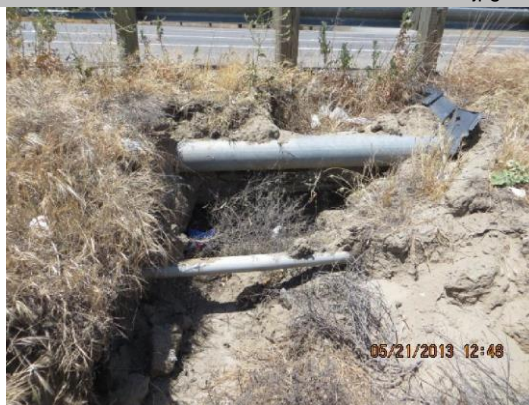
Photo 1 of 2 : UCIP_SP_2017_15174_24920.jpg

LM Start	0.23	Rating **	M	Issue No.	61							
LM End	0.23	Issue Type +	En	Location *	WS							
Category	Supplemental		GPS Latitude/Longitude									
			Start	End								
Item	DWR UCIP Field Study		37.784586 °	37.784586 °								
			-121.306837 °	-121.306837 °								
DWR ID												
Comment Code												
Inspector Comment												
FS_ID:15174 DS_ID:23110 EP_NO: N/A Repair Type: Non-Urgent Crossing Status: Found UCIP Comments: No permit identified for this crossing. FIELD_STRUCT_DESC: 1.5-inch PVC conduit 1-foot below the road surface within roadway fill over levee crown. FS Date: 5/22/2013

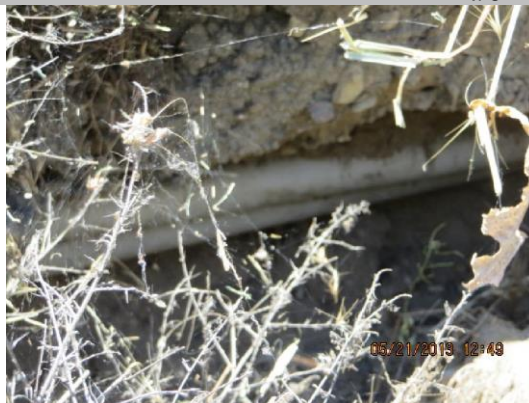
Photo 2 of 2 : UCIP_SP_2017_15174_24921.jpg

LM Start	0.23	Rating **	M	Issue No.	61 (cont)	
LM End	0.23	Issue Type +	En	Location *	WS	
Category	Supplemental			GPS Latitude/Longitude		
				Start		End
Item	DWR UCIP Field Study			37.784586 °		37.784586 °
				-121.306837 °		-121.306837 °
DWR ID						
Comment Code						
Inspector Comment						
FS_ID:15174 DS_ID:23110 EP_NO: N/A Repair Type: Non-Urgent Crossing Status: Found UCIP Comments: No permit identified for this crossing. FIELD_STRUCT_DESC: 1.5-inch PVC conduit 1-foot below the road surface within roadway fill over levee crown. FS Date: 5/22/2013

Pipes visible on LS next to roadway.

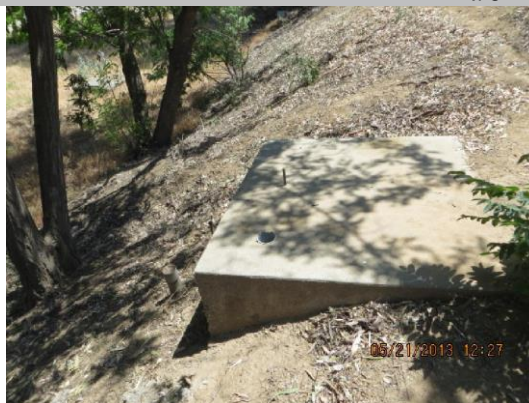
Photo 1 of 1 : UCIP_SP_2017_16188_27296.jpg

LM Start	0.27	Rating **	M	Issue No.	62
LM End	0.27	Issue Type +	En	Location *	WS
Category	Supplemental			GPS Latitude/Longitude	
				Start	End
Item	DWR UCIP Field Study			37.784194 °	37.784194 °
				-121.306353 °	-121.306353 °
DWR ID					
Comment Code					
Inspector Comment					
FS_ID:16188					
DS_ID:19055					
EP_NO: 12101B					
Repair Type: Non-Urgent					
Crossing Status: Found					
UCIP Comments: Appears abandoned and should be done so properly.					
FIELD_STRUCT_DESC: 4" electrical conduit through the levee 2.5 feet below the crown. Distribution panel on a 5-foot by 6-foot concrete pad on the WS shoulder (Permit No 12101B, 1979).					
FS Date: 5/21/2013

5X5 concrete pad with exposed electrical conduit on WS shoulder.

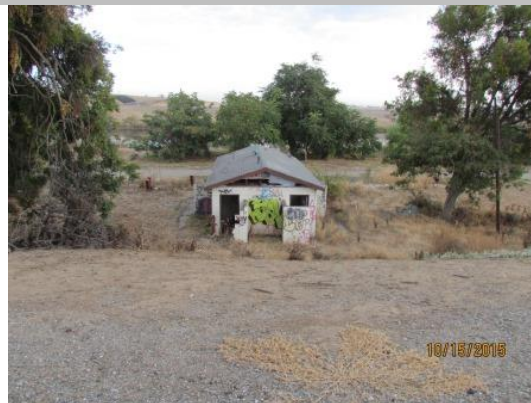
Photo 1 of 1 : SP_2017_RD2107_329_20_20170313_00007.jpg

LM Start	0.32	Rating **	M	Issue No.	20
LM End	0.32	Issue Type +	En	Location *	WS
Category	Earthen Levee			GPS Latitude/Longitude	
				Start	End
Item	Encroachments			37.783649 °	37.783649 °
				-121.305710 °	-121.305710 °
DWR ID	DWR_RD2107_01_f_2015_20				
Comment Code					
BU : Building					
Inspector Comment					
Building in the floodway may impede flood flows.

View of the building in the floodway.

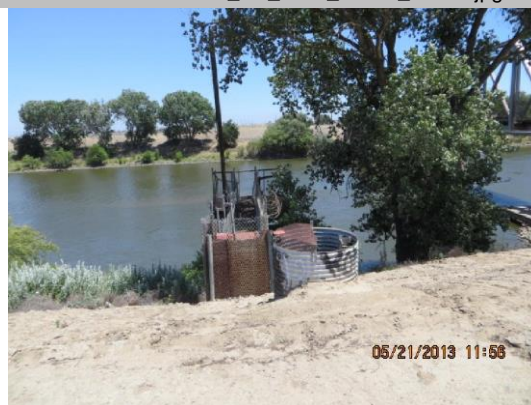
Photo 1 of 3 : UCIP_SP_2017_13684_22411.jpg

LM Start	0.68	Rating **	M	Issue No.	63
LM End	0.68	Issue Type +	En	Location *	WS
Category	Supplemental			GPS Latitude/Longitude	
				Start	End
Item	DWR UCIP Field Study			37.779486 °	37.779486 °
				-121.301961 °	-121.301961 °
DWR ID					
Comment Code					
Inspector Comment					
FS_ID:13684 DS_ID:19036 EP_NO: N/A Repair Type: Non-Urgent Crossing Status: Found UCIP Comments: Wooden walkway to pump on platform is in disrepair and may be a hazard. FIELD_STRUCT_DESC: 1 of 2: 14-inch pipe through the levee 17.0 feet below the crown. Pump on pile structure in the stream. Walkway to pump. Slide gate in 48-inch CMP riser on WS shoulder. 36-inch concrete standpipe at the landward toe. Service pole and circuit panel on landward toe. Originally included in O&M manual, 1964. FS Date: 5/21/2013

Pier and 48-inch CMP riser on WS shoulder

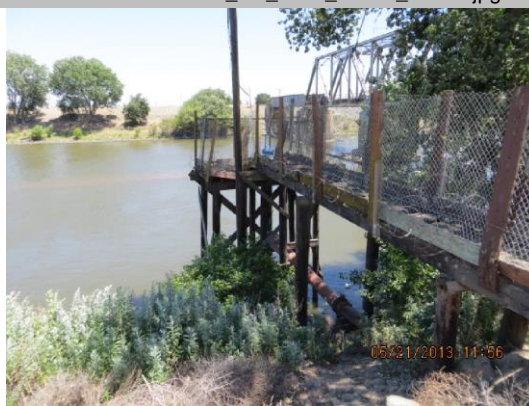
Photo 2 of 3 : UCIP_SP_2017_13684_22410.jpg

LM Start	0.68	Rating **	M	Issue No.	63 (cont)	
LM End	0.68	Issue Type +	En	Location *	WS	
Category	Supplemental			GPS Latitude/Longitude		
				Start		End
Item	DWR UCIP Field Study			37.779486 °	37.779486 °	
				-121.301961 °	-121.301961 °	
DWR ID						
Comment Code						
Inspector Comment						
FS_ID:13684 DS_ID:19036 EP_NO: N/A Repair Type: Non-Urgent Crossing Status: Found UCIP Comments: Wooden walkway to pump on platform is in disrepair and may be a hazard. FIELD_STRUCT_DESC: 1 of 2: 14-inch pipe through the levee 17.0 feet below the crown. Pump on pile structure in the stream. Walkway to pump. Slide gate in 48-inch CMP riser on WS shoulder. 36-inch concrete standpipe at the landward toe. Service pole and circuit panel on landward toe. Originally included in O&M manual, 1964. FS Date: 5/21/2013

Walkway to pump on pier at WS.

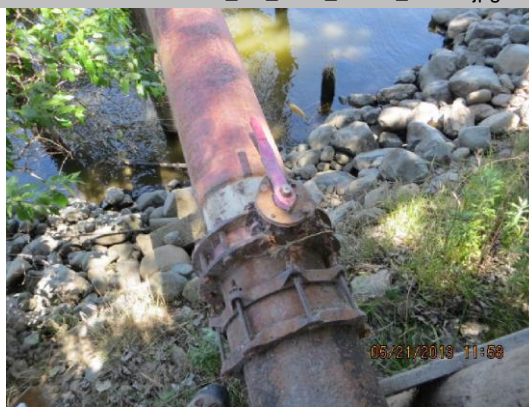
Photo 3 of 3 : UCIP_SP_2017_13684_22409.jpg

Butterfly valve on WS toe.

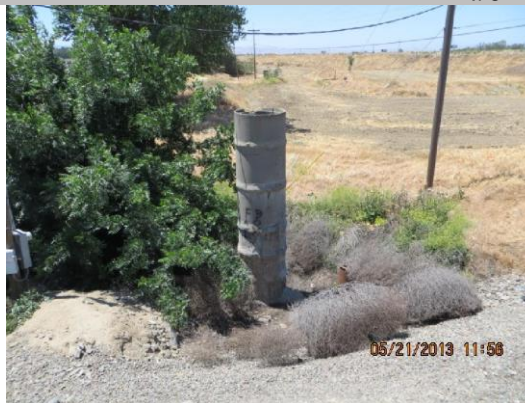
Photo 1 of 2 : UCIP_SP_2017_13883_22821.jpg

LM Start	0.70	Rating **	M	Issue No.	64
LM End	0.70	Issue Type +	En	Location *	WS
Category	Supplemental			GPS Latitude/Longitude	
				Start	End
Item	DWR UCIP Field Study			37.779209 °	37.779209 °
				-121.301973 °	-121.301973 °
DWR ID					
Comment Code					
Inspector Comment					
FS_ID:13883 DS_ID:19039 EP_NO: N/A Repair Type: Non-Urgent Crossing Status: Found UCIP Comments: Slide gate missing actuator inside 55-inch CMP riser. FIELD_STRUCT_DESC: 14-inch pipe through the levee, 15.0 feet below the crown. Pipe likely runs from 36-inch concrete standpipe on LS to outlet on WS toe. Portion of the discharge line from the pump at Levee Mile 0.68. 55-inch CMP riser with slide gate on LS shoulder. Originally included in O&M manual, 1964. FS Date: 5/21/2013

36-inch concrete standpipe on LS toe.

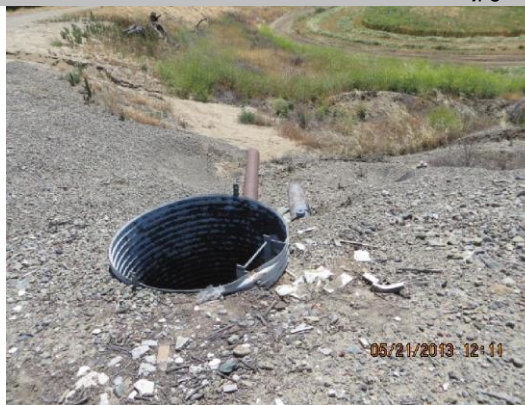
Photo 2 of 2 : UCIP_SP_2017_13883_22822.jpg

55-inch CMP riser with slide gate (no handle) on LS shoulder. 14-inch and 12-inch pipe visible on LS toe.

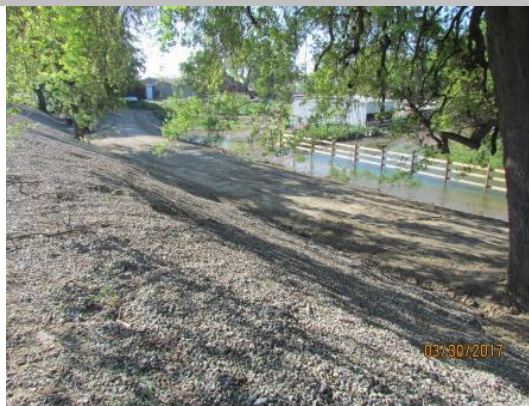
Photo 1 of 1 : SP_2017_RD2107_329_16_20170405_00026.jpg

View of the seepage berm at the levee toe.

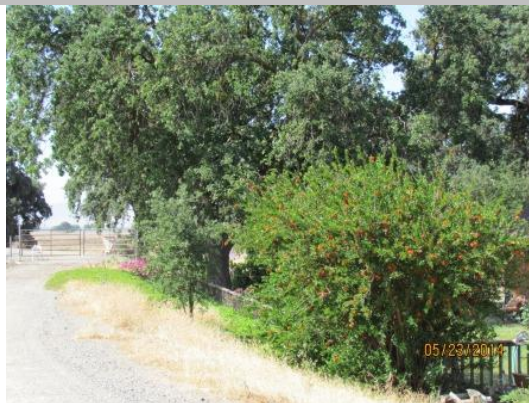
Photo 1 of 1 : SP_2017_RD2107_329_17_20170313_00004.jpg

LM Start	1.23	Rating **	M	Issue No.	17
LM End	1.23	Issue Type +	En	Location *	LS
Category	Earthen Levee			GPS Latitude/Longitude	
				Start	End
Item	Vegetation			37.774123 °	37.774123 °
				-121.307189 °	-121.307189 °
DWR ID	DWR_RD2107_01_s_2012_17				
Comment Code					
V6 : Landscaping					
Inspector Comment					
Landscaping and fence present on levee slope.

View of landscape planting on landside levee slope and a 3-ft yard fence at the levee toe.

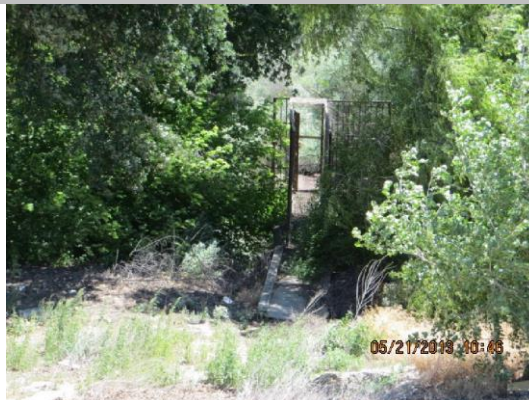
Photo 1 of 3 : UCIP_SP_2017_13650_22341.jpg

LM Start	1.47	Rating **	M	Issue No.	66
LM End	1.47	Issue Type +	En	Location *	LS
Category	Supplemental		GPS Latitude/Longitude		
			Start	End	
Item	DWR UCIP Field Study		37.771735 °	37.771735 °	
			-121.304847 °	-121.304847 °	
DWR ID					
Comment Code					
Inspector Comment					
FS_ID:13650 DS_ID:19040 EP_NO: N/A Repair Type: Non-Urgent Crossing Status: Found UCIP Comments: No pump. Appears abandoned. Large hole under pipe on WS slope from animal activity. FIELD_STRUCT_DESC: 1 of 2: 18-inch PVC irrigation pipe through the levee 2.5 feet below the crown. Pump on pile structure in the stream. Walkway to the pump. Originally included O&M manual, 1964. FS Date: 5/21/2013

Pumping plant on metal pier on WS toe.

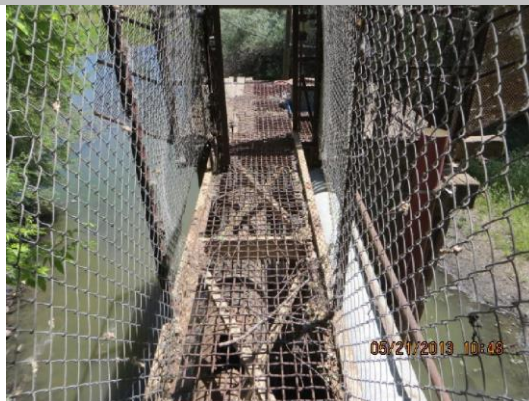
Photo 3 of 3 : UCIP_SP_2017_13650_22339.jpg

Pumping plant on metal pier on WS toe. Pipe visible on right under walkway.

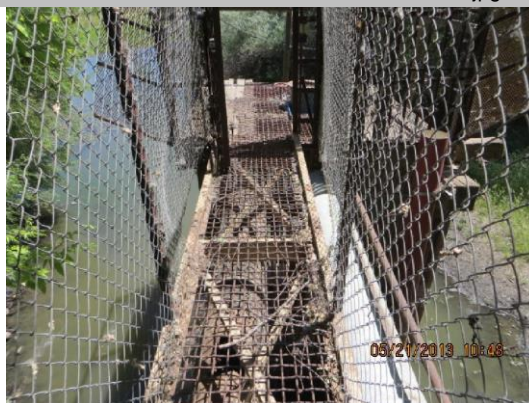
Photo 2 of 3 : UCIP_SP_2017_15179_24934.jpg

Pipe visible under metal walkway on WS slope.

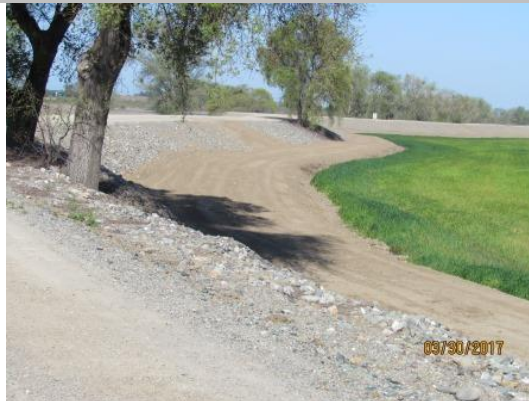
Photo 1 of 1 : SP_2017_RD2107_330_10_20170405_00012.jpg

View of the seepage berm at the levee toe.

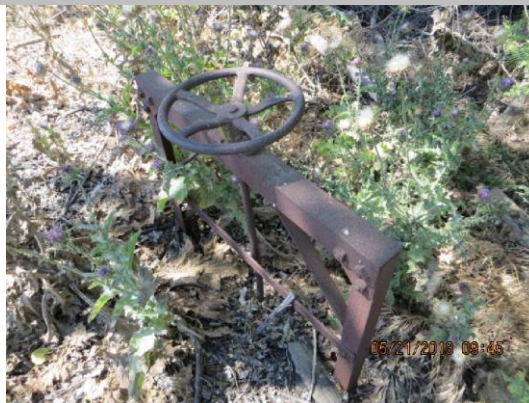
Photo 2 of 2 : UCIP_SP_2017_13637_22298.jpg

Slide gate visible on WS toe.

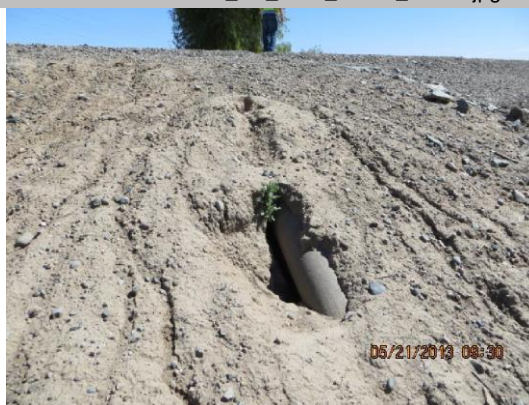
Photo 1 of 3 : UCIP_SP_2017_13636_22296.jpg

LM Start	0.54	Rating **	M	Issue No.	13
LM End	0.54	Issue Type +	En	Location *	LS
Category	Supplemental			GPS Latitude/Longitude	
				Start	End
Item	DWR UCIP Field Study			37.764832 °	37.764832 °
				-121.317405 °	-121.317405 °
DWR ID					
Comment Code					
Inspector Comment					
FS_ID:13636 DS_ID:19058 EP_NO: 13161 Repair Type: Non-Urgent Crossing Status: Found UCIP Comments: Some erosion along pipe alignment on WS slope. FIELD_STRUCT_DESC: 10-inch steel storm drain pipe through the levee 5-feet below the crown. Pump located on 36-inch concrete standpipe at LS toe. A PVC pipe runs parallel to waterward toe to train tracks. Air relief valve on waterward shoulder (Permit No. 13161, 1981). FS Date: 5/21/2013

Erosion along pipe alignment on WS slope.

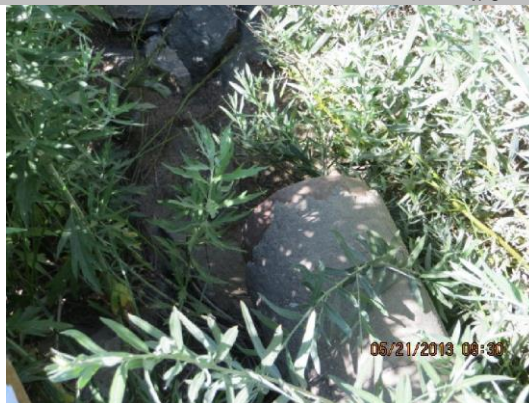
Photo 2 of 3 : UCIP_SP_2017_13636_22295.jpg

LM Start	0.54	Rating **	M	Issue No.	13 (cont)
LM End	0.54	Issue Type +	En	Location *	LS
Category	Supplemental			GPS Latitude/Longitude	
				Start	End
Item	DWR UCIP Field Study			37.764832 °	37.764832 °
				-121.317405 °	-121.317405 °
DWR ID					
Comment Code					
Inspector Comment					
FS_ID:13636					
DS_ID:19058					
EP_NO: 13161					
Repair Type: Non-Urgent					
Crossing Status: Found					
UCIP Comments: Some erosion along pipe alignment on WS slope.					
FIELD_STRUCT_DESC: 10-inch steel storm drain pipe through the					
levee 5-feet below the crown. Pump located on 36-inch concrete					
standpipe at LS toe. A PVC pipe runs parallel to waterward toe to train					
tracks. Air relief valve on waterward shoulder (Permit No. 13161, 1981).					
FS Date: 5/21/2013

Pipe at outlet.

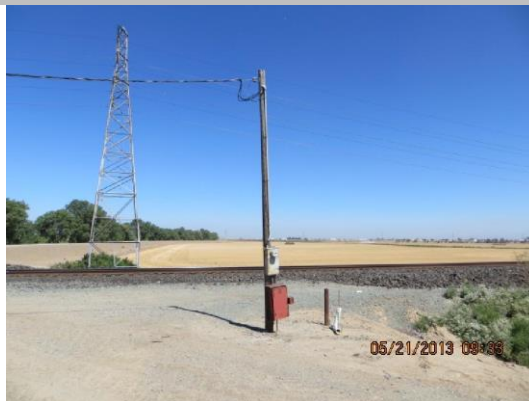
Photo 3 of 3 : UCIP_SP_2017_13636_22294.jpg

JP and meter on LS shoulder.

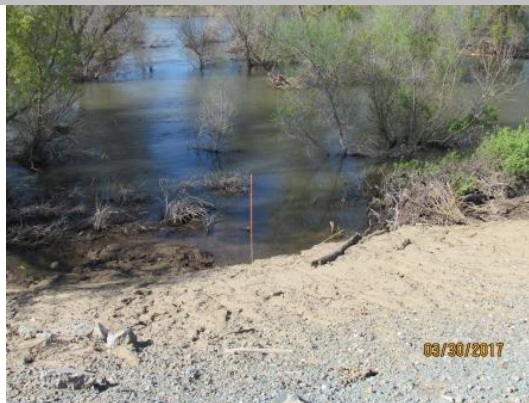
Photo 1 of 1 : SP_2017_RD2107_330_4_20170405_00013.jpg

LM Start	1.01	Rating **	U	Issue No.	4
LM End	1.01	Issue Type +	Ma	Location *	WS
Category	Earthen Levee			GPS Latitude/Longitude	
				Start	End
Item	Erosion / Bank Caving			37.769832 °	37.769832 °
				-121.322758 °	-121.322758 °
DWR ID	DWR_RD2107_02_s_2017_4				
Comment Code					
E2 : Schedule repair of erosion site prior to the next inspection.					
Inspector Comment					
10 ft erosion at waterside toe.

View of the erosion at the waterside levee toe.

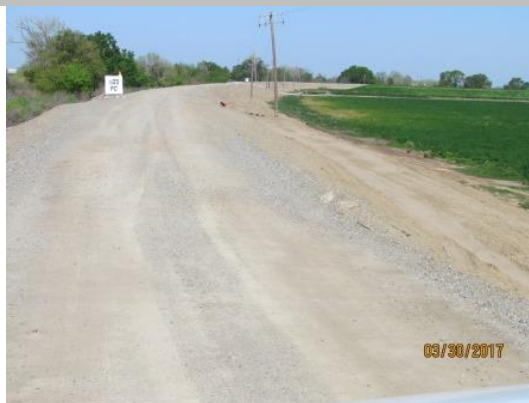
Photo 1 of 1 : SP_2017_RD2107_330_11_20170405_00014.jpg

LM Start	1.26	Rating **	A	Issue No.	11
LM End	1.80	Issue Type +	Ob	Location *	LS
Category	Earthen Levee			GPS Latitude/Longitude	
				Start	End
Item	Seepage / Sandboils			37.771978 °	37.777557 °
				-121.326449 °	-121.332903 °
DWR ID	DWR_RD2107_02_s_2017_11				
Comment Code					
Inspector Comment					
LMA installed seepage stability berm at levee toe due to February 2017 storms.

View of the seepage berm at the levee toe.

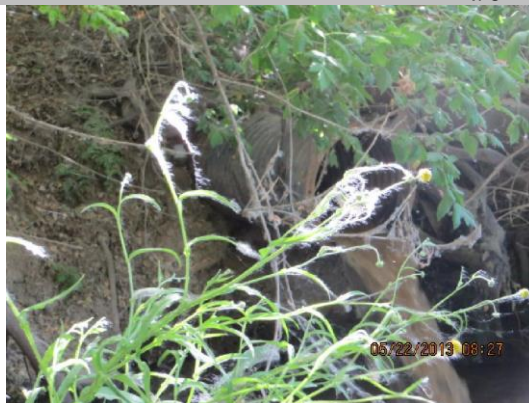
Photo 1 of 3 : UCIP_SP_2017_51641_22441.jpg

FS_ID:51641
DS_ID:19056
EP_NO: 2966
Repair Type: Urgent
Crossing Status: Found
UCIP Comments: 11/16/2016 Visible hole through pipe visible on WS end. Sink hole present at the LS ditch. Evidence of pipe repair visible on LS (see photos) however, no permit was found to document the work. Need to contact owner to determine permit authorizing work. Due to the hole in the pipe recommend internal inspection of the pipe through the levee to determine pipe integrity. (O. Magana - DWR UCIP)05/22/2013 Headwall around pipe at LS toe is failing and should be shored up. Flap gate propped open and should be returned to normal function. (W. Wylie - DWR UCIP)
FIELD_STRUCT_DESC: 24-inch steel drain pipe through the levee 14 feet below the crown. Flap gate installed on the waterward end of the pipe and two standard reinforced concrete cutoff walls were placed around the pipe in line with the levee shoulders (Permit No. 2966, 1958 - Dell'Osso Brothers).

Pipe visible on WS toe with Flap gate open.

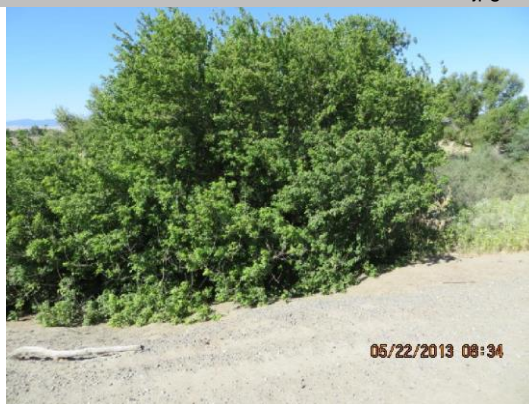
Photo 2 of 3 : UCIP_SP_2017_51641_22440.jpg

Pipes visible under foliage on WS toe.

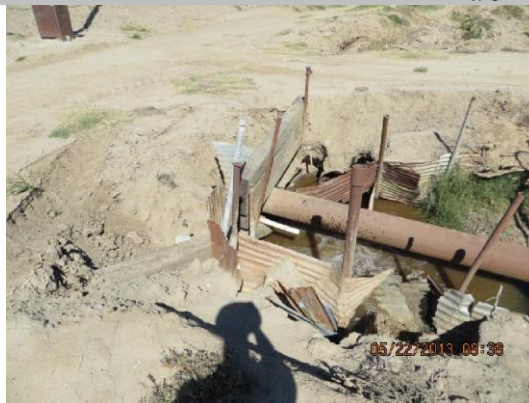
Photo 3 of 3 : UCIP_SP_2017_51641_22439.jpg

Comment Code					
Inspector Comment					
FS_ID:51641 DS_ID:19056 EP_NO: 2966 Repair Type: Urgent Crossing Status: Found UCIP Comments: 11/16/2016 Visible hole through pipe visible on WS end. Sink hole present at the LS ditch. Evidence of pipe repair visible on LS (see photos) however, no permit was found to document the work. Need to contact owner to determine permit authorizing work. Due to the hole in the pipe recommend internal inspection of the pipe through the levee to determine pipe integrity. (O. Magana - DWR UCIP)05/22/2013 Headwall around pipe at LS toe is failing and should be shored up. Flap gate propped open and should be returned to normal function. (W. Wylie - DWR UCIP) FIELD_STRUCT_DESC: 24-inch steel drain pipe through the levee 14 feet below the crown. Flap gate installed on the waterward end of the pipe and two standard reinforced concrete cutoff walls were placed around the pipe in line with the levee shoulders (Permit No. 2966, 1958 - Dell'Osso Brothers). FS Date: 11/17/2016 10:50:00 AM

Headwall failing at drainage ditch on LS toe.
